Fleish Flume, Overflow, and Tailpiece Replacement

2020 APWA Project of the Year Nomination – Historical Restoration / Preservation under \$5M

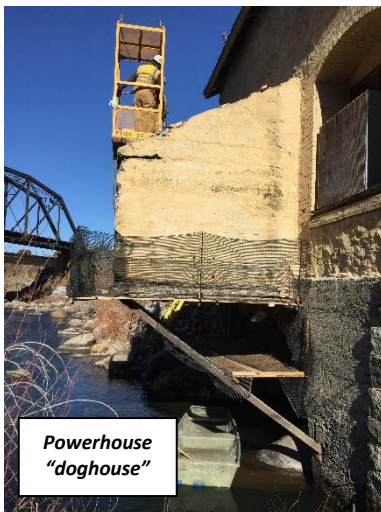
Powerhouse
"doghouse"

Replacing the broken tailpiece pipe presented a daunting challenge. The outlet broke off when the river flow was high. The structural engineer had to wait until after the spring runoff had subsided to conduct an inspection. The only access was by rowboat in the swift current. Access was further complicated because the outlets were located in a recessed archway submerged in the river underneath the building with a cantilevered concrete doghouse perched above. Again, several conditions regarding the pipe connection and rubble building construction had to be assumed because of the nearly impossible access.

The condition of the existing turbine outlet structure was impossible to determine until construction began since the remaining tailpiece remained submerged in the Truckee River. The first order of business was to improve access by removing the obsolete concrete doghouse cantilevered over the recessed tailpiece arch. TMWA had great concerns that no demolition debris would end up in the river. A series of catch nets surrounded the structure as the contractor cut the structure free and lifted it by crane to the shore. The concrete doghouse was demolished and transported to a crushing plant for recycling. Access remained difficult because the outlet pipes were in an arch tunnel recessed six feet inside of the building exterior walls. A preliminary investigation by SCUBA divers concluded that the inverts of both tailpiece pipes had rusted away and large holes cavitared into the concrete encasement. With the removal of the second tailpiece pipe, the structural engineer was able to confirm corrosion and cavitation in both pipes. Not anticipating the cavitation, the structural engineer drafted a revised repair whereby the existing pipes would remain, the cavitation holes would be filled with grout, and a steel invert would then be welded to the existing pipe to protect the grout.
